Smoke and Dye-Water Observation Summary

Western Run Pilot Project - Baltimore Maryland

STREET: FORDHAM DR. TEST 196 A 4	MAP #1: 1	MH: 1521076
CITY: BALTIMORE	MAP #2:	MH: 1521077
LOCALE: SMALL RESIDENTIAL STREET	TAPE #: JAM 1	TV'D LGTH: 58.15 ft
INSPECT REASON: OTHER	PIPE SIZE: 8 in	
SECTION TYPE: WASTEWATER	MATERIAL: VCP JT LGTH:	
AREA: 01-WR27	LINING: NO RELINING	
	RSRVD:

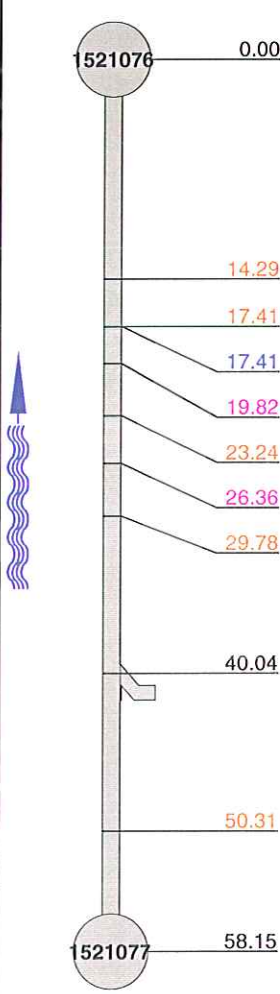
0.00	inspection begins at downstream manhole, 1521076	0	00:24:56	
	14.29	Infiltration Running at joint at 02 o'clock TO 5 O'CLOCK	3	00:29:49	25a, b
	17.41	Infiltration Running at joint at 03 o'clock	3	00:30:52	26a
	17.41	Infiltration Seeping at joint at 09 o'clock	2	00:30:52	27a
	19.82	Infiltration Gushing at joint at 04 o'clock	4	00:31:19	28a
	23.24	Infiltration Running at joint at 04 o'clock	3	00:31:55	29a
	26.36	Infiltration Gushing at joint at 03 o'clock	4	00:32:28	30a
	29.78	Infiltration Running at joint at 03 o'clock	3	00:33:13	31a
	40.04	service connection at 09 o'clock	0	00:35:25	
	50.31	Infiltration Running at joint at 03 o'clock	3	00:36:27	33a
	58.15	inspection ends at upstream manhole, 1521077	0	00:37:25

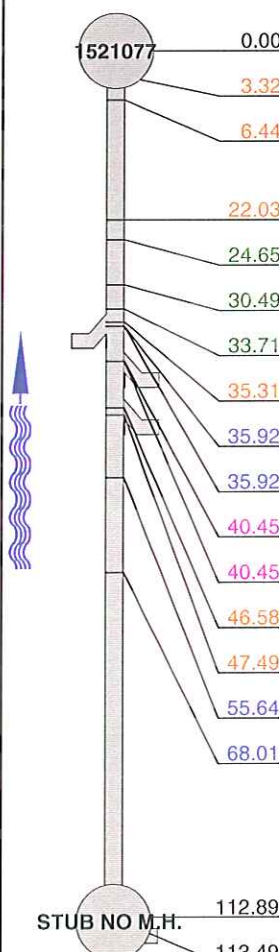
0.00	inspection begins at downstream manhole, 1521077	0	00:37:25	
	3.32	Infiltration Running at joint at 04 o'clock	3	00:38:34	36a

6.44	Infiltration Running at joint at 04 o'clock	3	00:39:30	37a
	22.03	Infiltration Running at joint at 04 o'clock	3	00:42:57	38a
	24.65	gasket exposed, from 02 to 04 o'clock	1	00:43:32	39a

30.49	roots light, from 01 to 04 o'clock	1	00:44:32	40a
	33.71	roots light, from 01 to 04 o'clock	1	00:44:59	41a
	35.31	service connection with infiltration running inside at 03 o'clock	3	00:45:35	42a

35.92	Infiltration Seeping at joint at 03 o'clock	2	00:45:58	43a
	35.92	Infiltration Seeping at joint at 11 o'clock	2	00:45:58	44a
	40.45	break-in-connection with infiltration gushing inside at 10 o'clock		00:46:57	45a

40.45	break-in-connection with infiltration gushing inside at 10 o'clock		00:47:34	46a
	46.58	service connection with infiltration running inside at 09 o'clock	3	00:48:31	47a

47.49	Infiltration Running at joint at 04 o'clock	3	00:48:55	48a
	55.64	roots medium, from 12 to 12 o'clock	2	00:49:29	49a
	68.01 S1	roots medium, from 12 to 12 o'clock, START	2	00:50:13	50a

112.89	service connection at 09 o'clock	0	00:52:08	
	113.49	inspection ends at STUB	0	00:52:25	53a

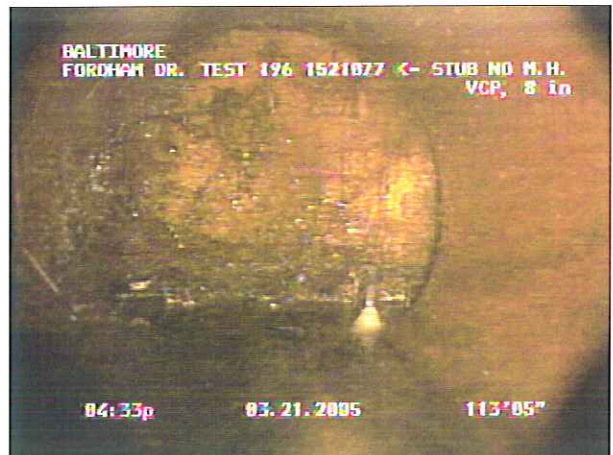
IMAGE: 53a, TAPE #: JAM 1, 00:52:25
113.49FT, inspection ends at STUB

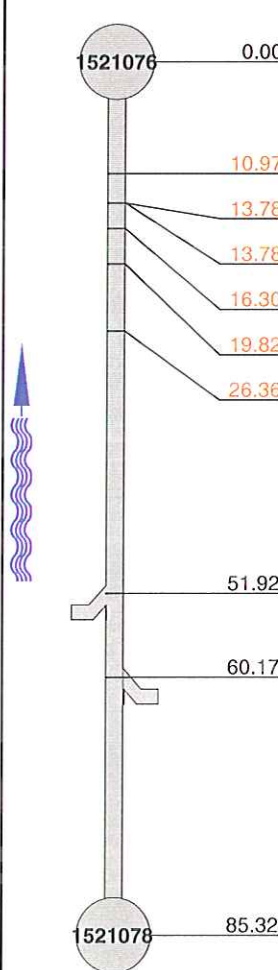
0.00	inspection begins at downstream manhole, 1521076	0	00:52:25	
	10.97	Infiltration Running at joint at 09 o'clock	3	00:54:00	55a
	13.78	Infiltration Running at joint at 02 o'clock	3	00:54:23	56a
	13.78	Infiltration Running at joint at 09 o'clock	3	00:54:40	57a
	16.30	Infiltration Running at joint at 12 o'clock to 12 o'clock	3	00:55:03	58a
	19.82	Infiltration Running at joint at 03 o'clock	3	00:55:26	59a
	26.36	Infiltration Running at joint at 09 o'clock	3	00:56:16	60a
	51.92	service connection capped at 03 o'clock	0	00:57:39	
	60.17	service connection capped at 09 o'clock	0	00:58:09	
	85.32	inspection ends at upstream manhole, 1521078	0	00:59:32
